Manhole Inspection Summary

Manhole # S51M__068MH

Insp Date: **4/4/08 1:28 PM**

Location Address: **905 s curley st**

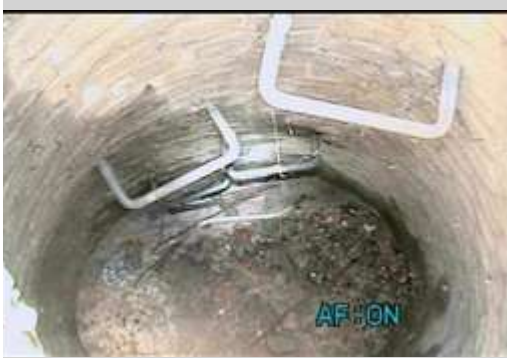
Miscellaneous

steps

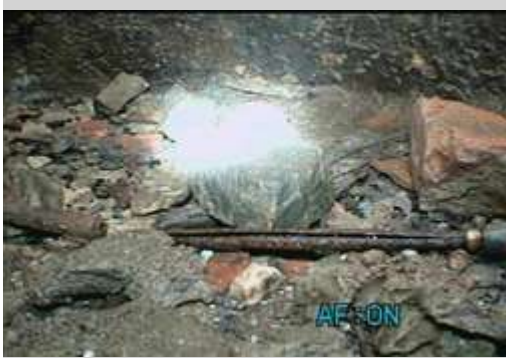
Defect 3

Condition: ☐ Sound ☐ Cracked ☐ Root Intrusion ☐ Deteriorated ☐ Leaks ☒ Debris

channel debris

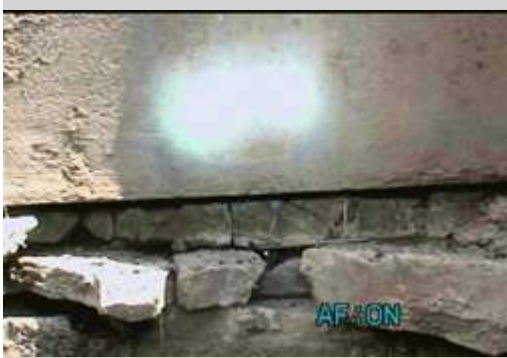
Defect 1

Condition: ☐ Sound ☐ Cracked ☐ Root Intrusion ☒ Loose Brick ☒ Deteriorated

frame adj

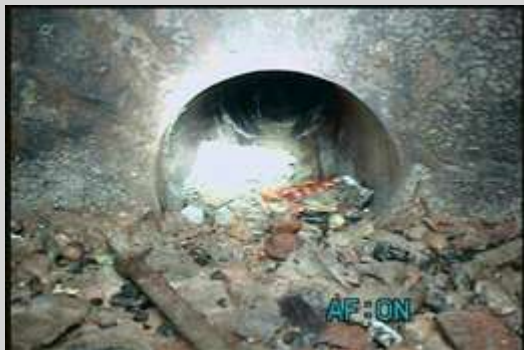
12 O'Clock Outflow

Deposits: ☐ None ☐ Mud ☐ Sludge ☒ **Debris** ☐ Grease

Silt Depth: **2** (in.) Deposits Extent: **Medium**
